Evaluation Tests Of Pop-Up Traffic Sentinel Manufactured By
Terra Engineering Co.

September 1968

State of California
Department of Public Works
Division of Highways
Materials and Research Department
5900 Folsom Blvd., Sacramento 95819

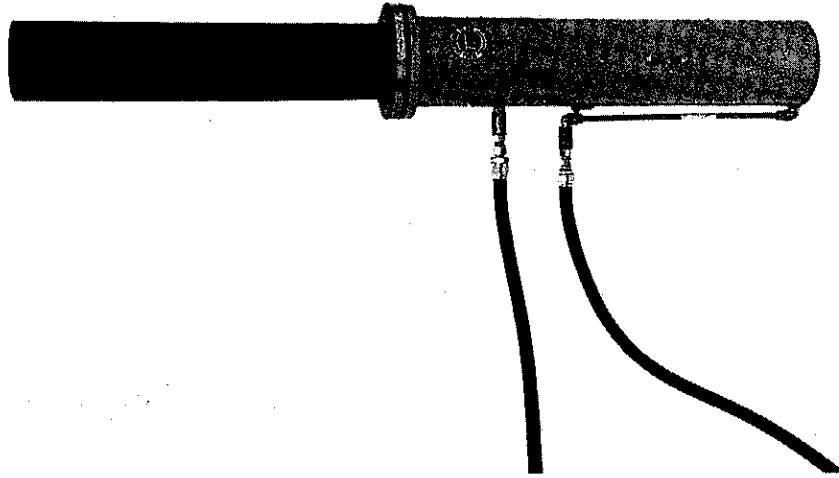
Exhibit 1

The device tested was a pop-up "Traffic Sentinel" lane control device manufactured by the Terra Engineering Co., Inc., 271 Figueroa Street, Monterey, California. The cost of this unit is approximately \$350 (Exhibit 1).

TUBE EXTENDED

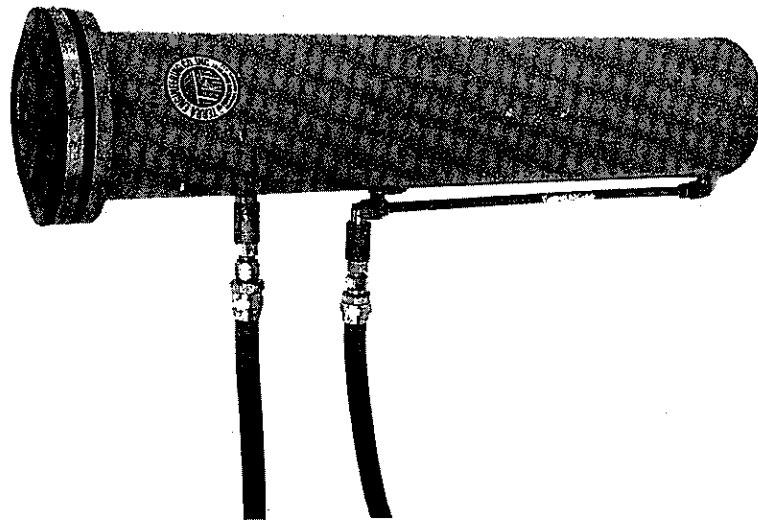
TUBE RETRACTED

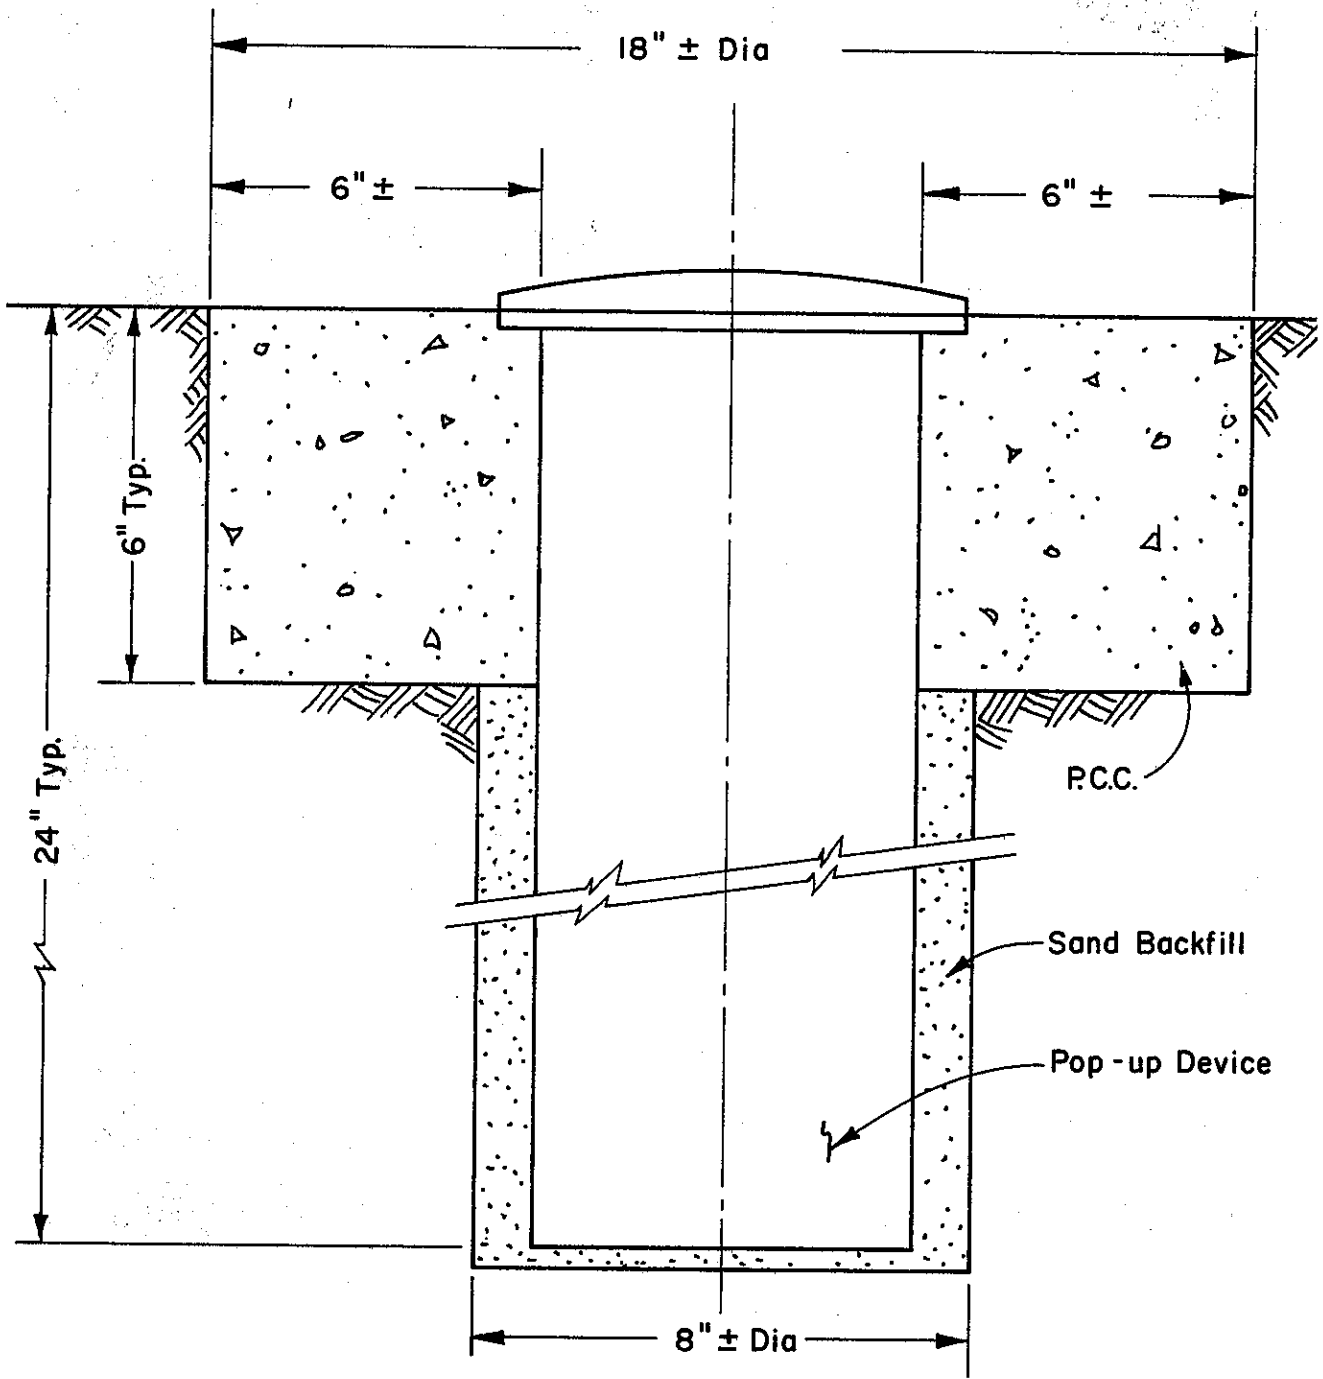
Exhibit 3

Installation details are as shown on attached Exhibit 3, and consisted of boring an 8-inch diameter by 24-inch deep hole with an 18-inch diameter by 6-inch deep area excavated at the top. The hole was filled with sand as required to position the top of the device approximately flush with the roadway surface. With the device centered vertically in the hole, the hole was backfilled with sand up to the excavated area. The approximately 6-inch deep excavated area was then filled with concrete up to the roadway surface forming a stabilizing collar.

The device is so constructed that the air supply outlets are located below the concrete collar, thus the air supply lines can be run below the roadway surface to the main supply line.

This installation operated satisfactorily throughout the physical tests and is recommended for experimental in-service installation.

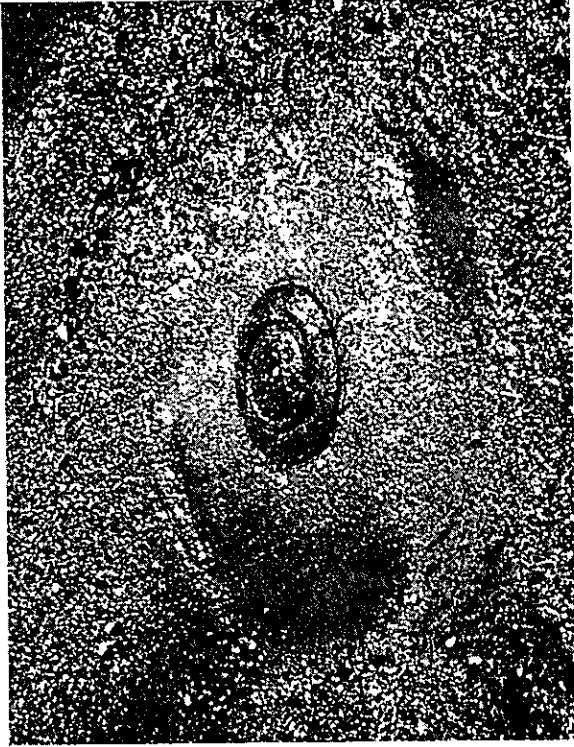
Before the impact test and with the tube in the down position, the installation was covered with sand and gravel and water was poured onto it. It was satisfactorily operated several times, up and down at an air pressure of 35 psi. The unit is designed so that a wiping action on the outer and inner surfaces of the tube takes place as it is extended and lowered, thus minimizing the passage of foreign material into the unit where it could cause jamming. On the particular model tested, the outer seal had excessive clearance and did not wipe satisfactorily. Although no operating problems were experienced, the manufacturer plans to correct the clearance on the future model.

Moisture and Grit Test - Tube Retracted

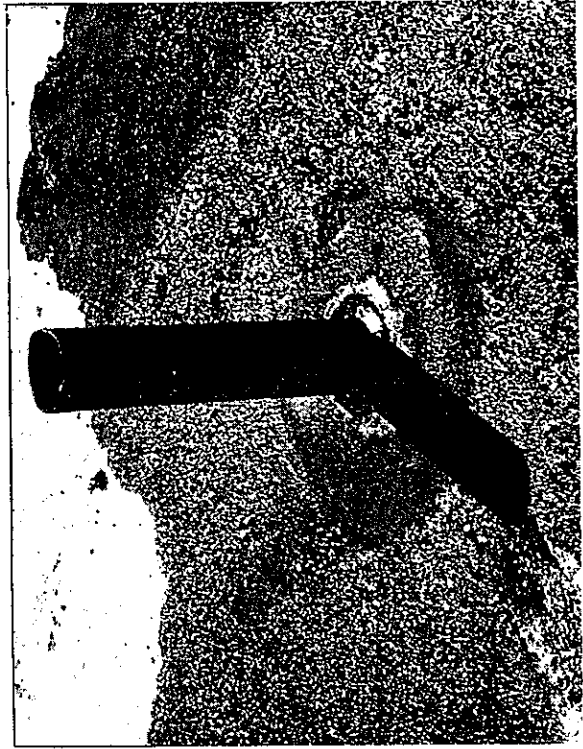
Moisture and Grit Test - Tube Extended

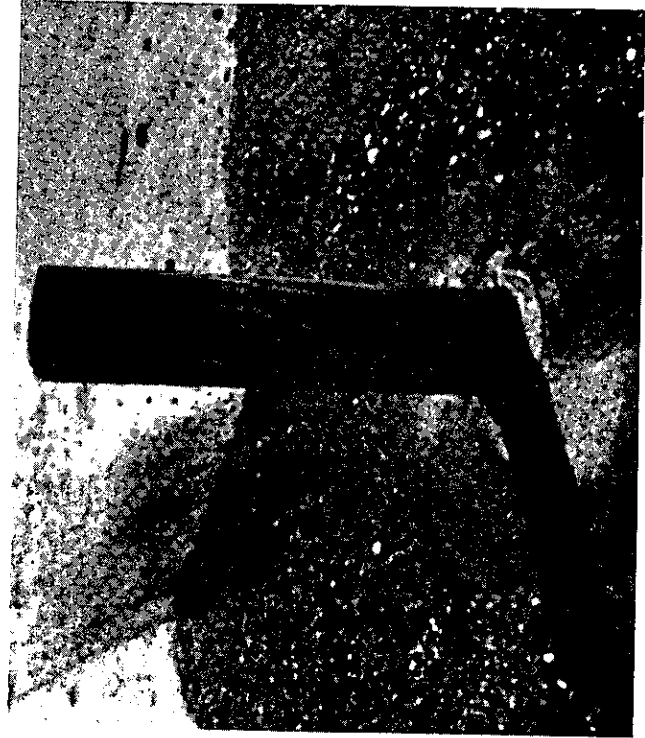
tire over the extended tube. On the first attempt it appeared that the brakes were inadvertently released just as the wheel passed over the tube. On the repeat test at 10 mph the left front tire skidded directly across the tube, deflecting and flattening it against the pavement. Other than black skid marks on the tube surface, no other damage was apparent to either the tube or the formed rubber inner and outer caps of the recessed casing. The tube returned immediately to the upright position and operation of the unit was unaffected by this impact.

Tube Damage - Test No. 5
